**Part Number: PK3B1-35G5S (Short Bed)**  
**PK3B1-35G6S (Long Bed)**

# TOYOTA TACOMA 2016 - TONNEAU COVER

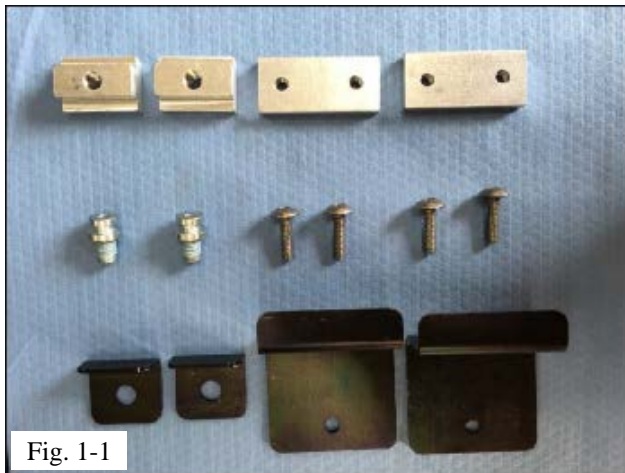
- (a) Verify all the bag contents for damage or missing parts (Fig. 1-1).

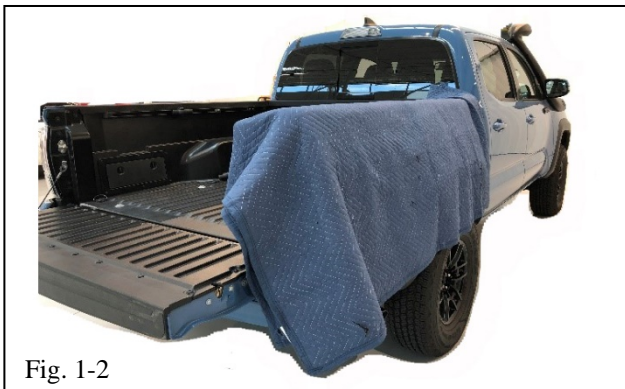
- (b) Place a blanket on the truck bed for protection (Fig 1-2).

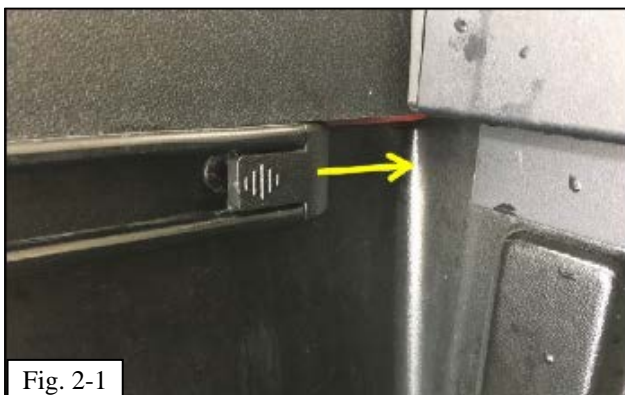
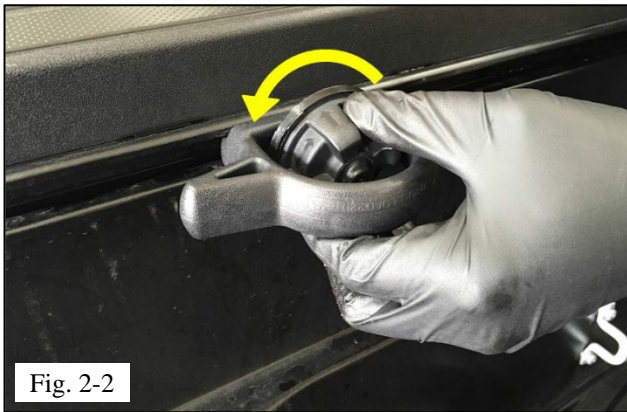
- (a) Remove the front-end caps from the vehicle's accessory rails (Fig. 2-1).

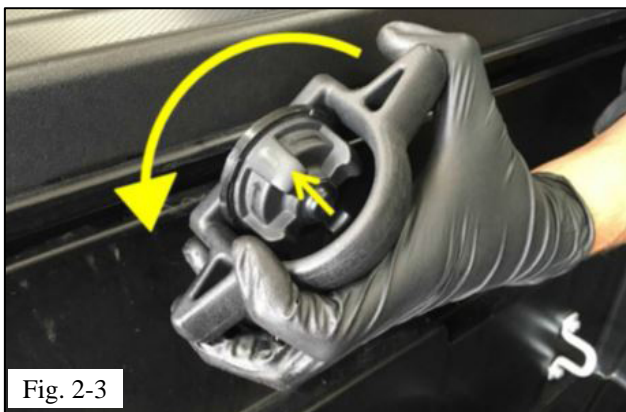
- (c) Remove the cleats. If the cleats are in the front half of the truck bed. Left side shown. Repeat for RH (Fig. 2-2).

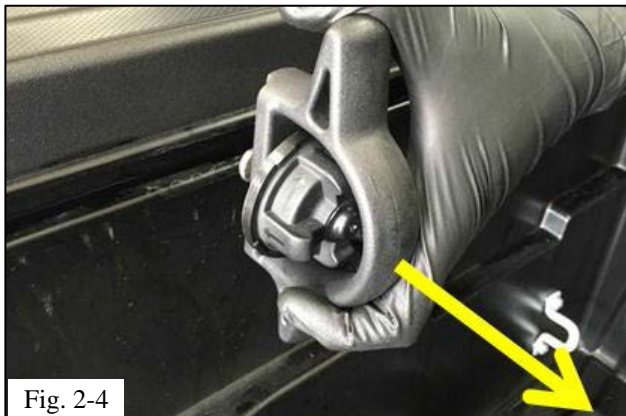
- (d) Depress knob and turn cleat. Left side shown. Repeat for RH (Fig. 2-3).

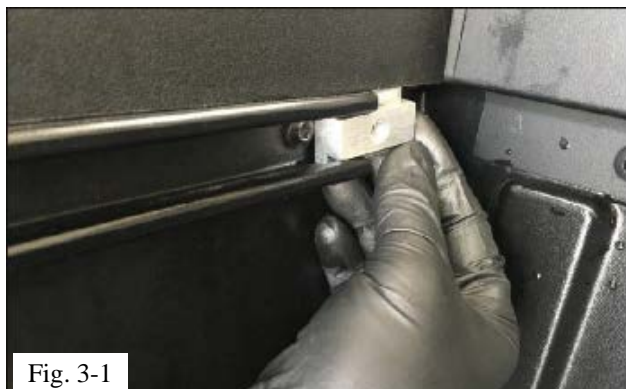
- (e) Remove cleat (Fig. 2-4). Keep the cleat for re-assembly. Left side shown. Repeat for RH.

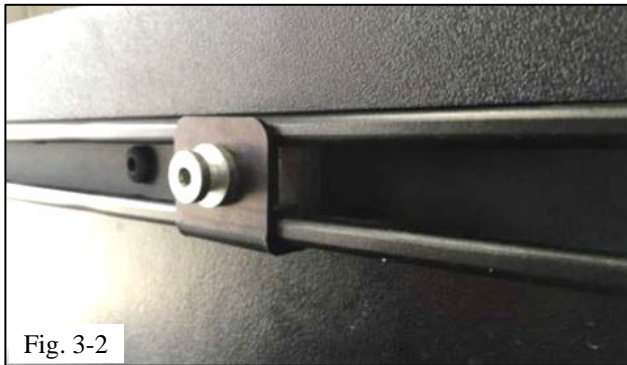
- (a) Slide the T-nut from the front of the rail (Fig. 3-1).

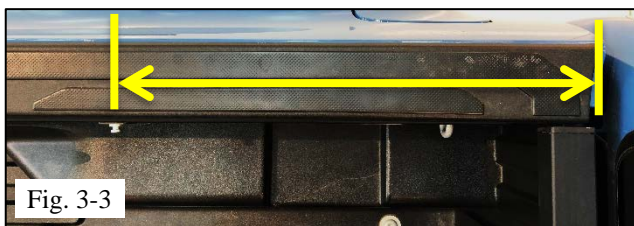
- (b) Attach the L- bracket to the T-nut using the shoulder bolt (Fig. 3-2). The L portion will sit under the accessory rail.

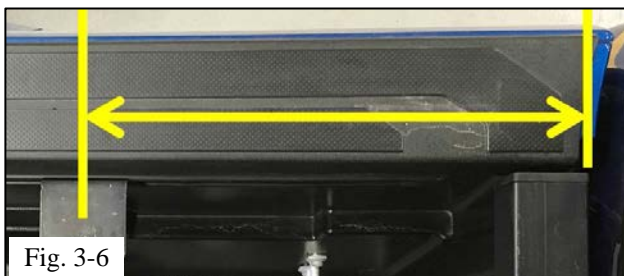
- (f) Slide the assembly from Step 3(e) into the accessory rail (Fig. 3-5).

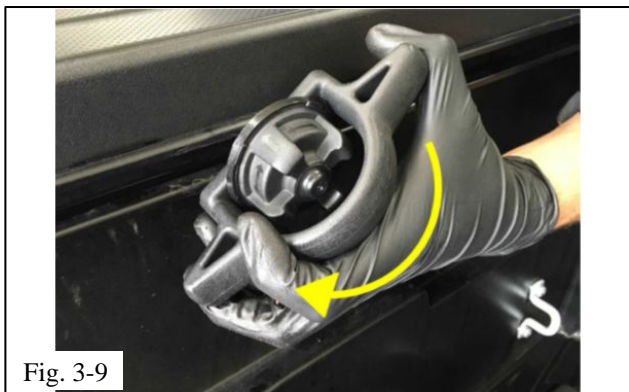
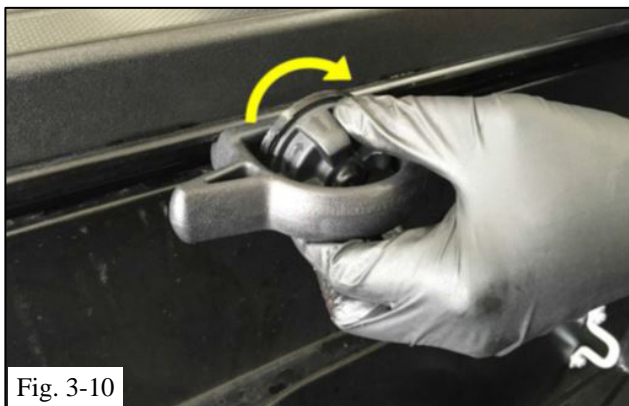
- (j) Re-insert cleats removed in Step 2(d) (Fig. 3-8 and Fig. 3-9).

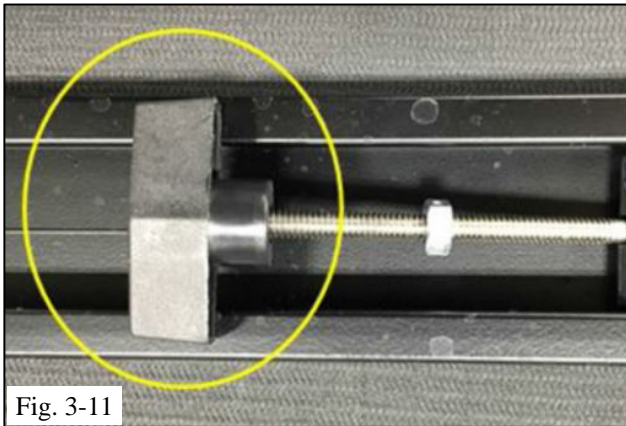
- (k) Slide cleat to an indent on the rail and tighten (Fig. 3-10).

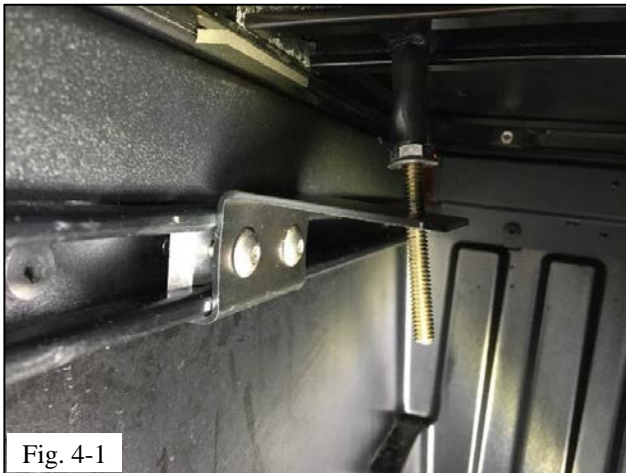
- (l) Remove T-handles from the threaded bolt on the front panel of the cover and retain the T-handles for re-installation (Fig. 3-11).
- (m) Remove the User Manual and place in glove box.

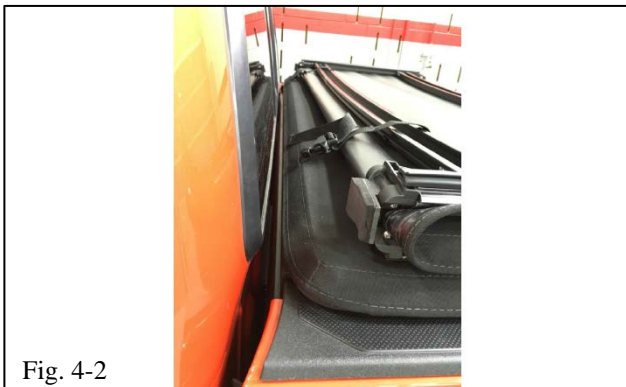
- (a) Place the tonneau cover on top of the bed and insert the threaded bolts (hanging from the cover) into the Z-brackets (Fig. 4-1 and Fig. 4-2). Left side shown. Repeat for RH.

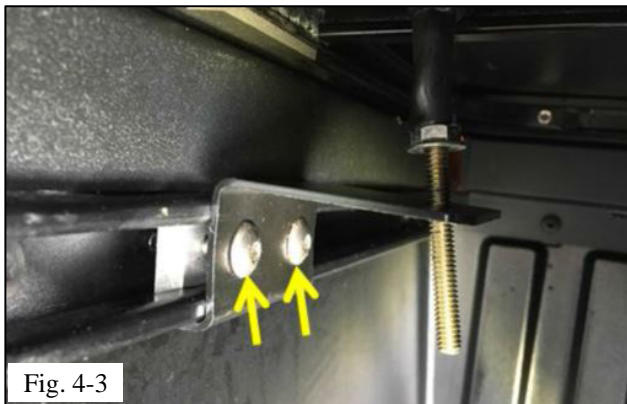
- (b) Align the front edge of the cover with the front edge of the bed (Fig. 4-2).

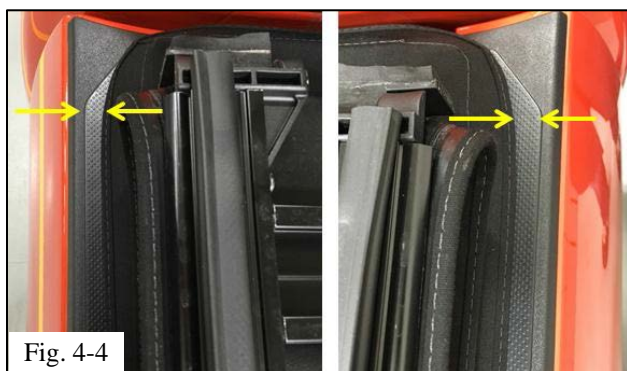
- (c) Tighten the panhead bolts to fix the Z-bracket location (Fig. 4-3).

**Torque: 4.5Nm (40 in-lb)**

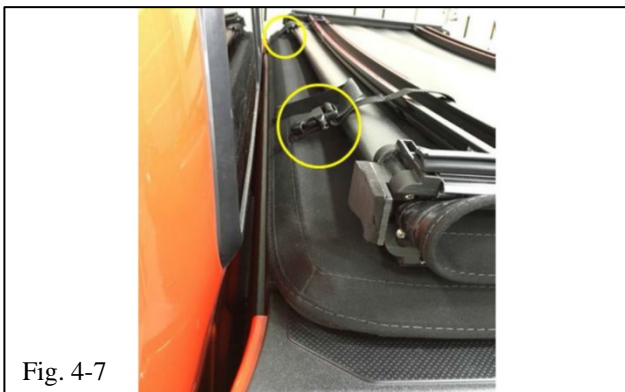
Fig. 4-6

- (f) Hook tether cable eyelet onto shoulder bolt installed in step 2c and torqued in step 3d (Fig. 4-6).

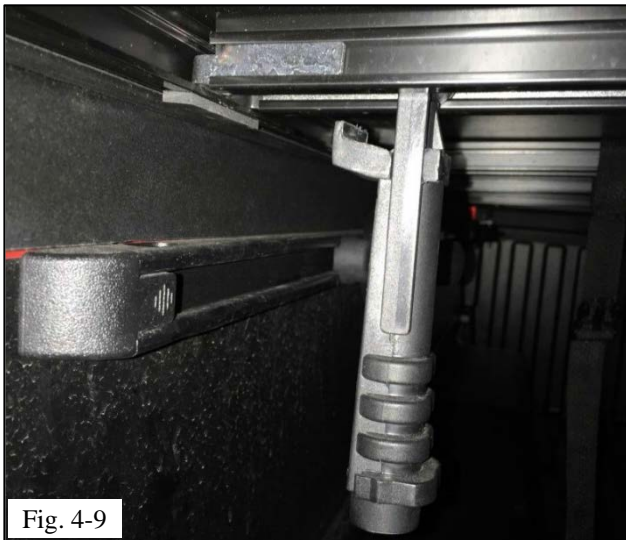
Fig. 4-8

- (h) Unfold cover and visually check for side-to-side alignment (Fig. 4-8).

**! NOTE: Improper side-to-side alignment can cause rear latch failure, which will result in excessive noise and damage to the cover.**

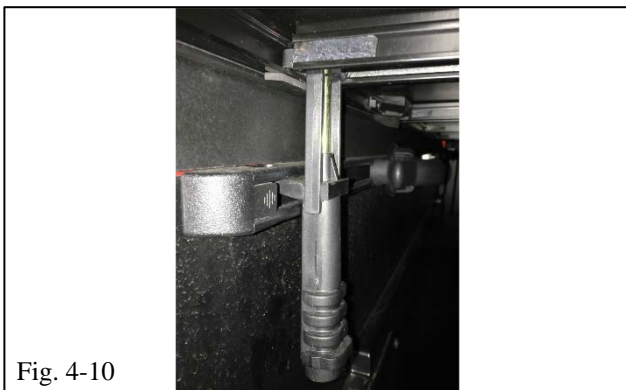
- (i) Pull down the rear latch handles from rear cross bow (Fig. 4-9).
