Part Number:**PU100-3415S-01, PK3B1-34H5H (Short)****PU100-3415R-01, PK3B1-34H6H (Reg.)****PU100-3415L-01, PK3B1-34H8H (Long)****Kit Contents**

TOYOTA TUNDRA 2016 - TONNEAU COVER

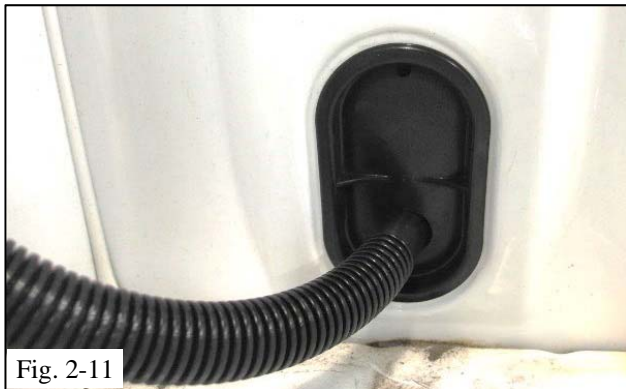
(k) Reinstall the plugs and route the drain tubes through the drilled holes (Fig. 2-11).

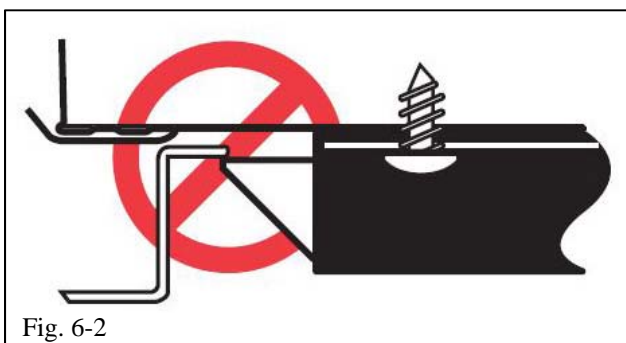
- (b) If the tail panel does not contact the side rails properly (Fig. 6-2), hand loosen the latch screws, slide the latch toward the side rail and retighten the screws by hand (Fig. 6-3).
