# Part Number: PT347-52043

# A. Attach Cargo Cover

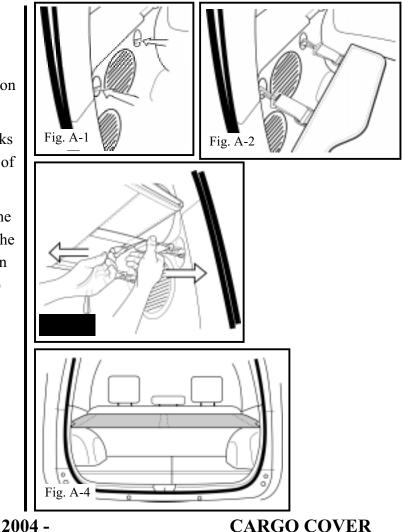
- 1. Open rear liftgate and locate anchor points on each side of the vehicle. (Fig. A-1)
- 2. Flip open sides of cargo cover. Attach hooks to D-rings as shown. Repeat for other side of vehicle. (Fig. A-2)
- Adjust tension on cargo cover by holding the tensioning buckle in one hand and pulling the web strap in the opposite direction as shown Repeat for other side of vehicle. (Fig. A-3)
  - i. Ensure that cover is centered across the vehicle.
  - 4. Flip sides of cargo cover back down. Final assembly should resemble (Fig A-4).
